A WHITE PAPER TO DOCUMENT THE FINDINGS AND CONCLUSIONS  
RESULTING FROM RAID GRANT PROJECT NO. 16NT-09 WHICH INVESTIGATED  
THE FUNCTION OF AN ORGANIC EVAPOTRANSPIRATION COVER FOR  
EROSION CONTROL IN AN ARID CLIMATE

## **SANDOVAL COUNTY, NEW MEXICO**

### **Organic Evapotranspiration Cover**

Parkhill Project # 01802320

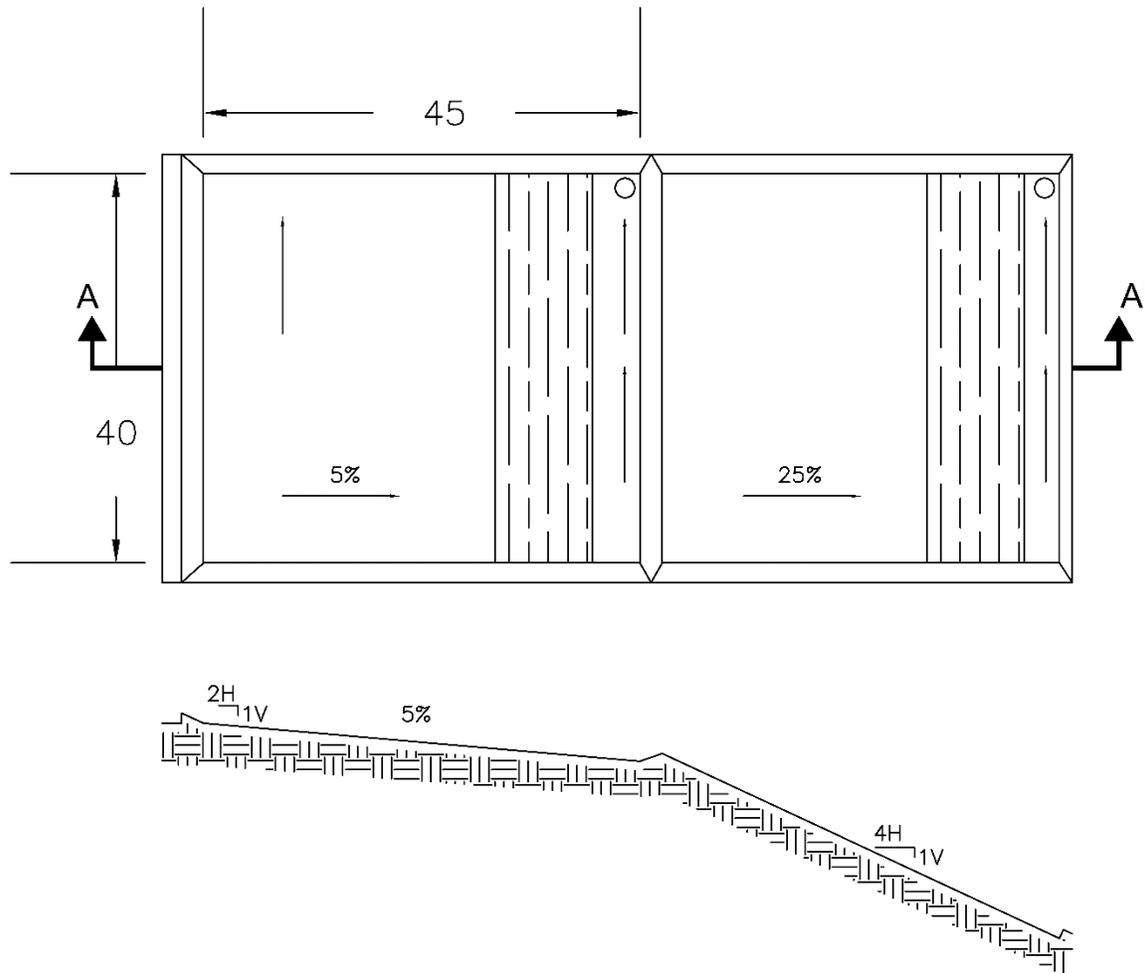
The construction plans depicted two lysimeter pads, one at a five (5) percent grade and the second at a twenty-five percent (25%) grade (depicted above). To allow for monitoring a 60-mil Flexible Membrane Liner (FML) was installed on top of the Intermediate cover in the Organic Evapotranspiration Cover System (depicted below). A 200-mil Geocomposite drainage layer, consisting of a geotextile bonded to a drainage net bonded to geotextile) was installed above the FML. This was included to allow any liquids that pass through the Infiltration Layer to collect in a sump situated in a downgradient corner of each lysimeter pad. Instrumentation was installed on the FML Liner to detect moisture prior to the placement of the Infiltration Layer. This instrumentation provided monitoring for measurable moisture percolation through the cover system.

6" EROSION/ORGANIC LAYER LOOSE WOOD CHIPS
	30" BARRIER (INFILTRATION) LAYER $K_s = 7.2 \times 10^{-4}$ cm/sec COMPACTED TO 90% STANDARD PROCTOR DENSITY DRY OF OPTIMUM MOISTURE
	12" INTERMEDIATE COVER (ON-SITE SOILS)
	WASTE

Installation of the FML and Geocomposite at the bottom of the infiltration layer allow the lysimeter to confirm the integrity of the Erosion/Organic Layer and the Barrier/Infiltration Layer that was approved in the last Permit Modification. The detection system consisted of fifteen moisture sensors distributed across each of the lysimeter pads. In addition, each lysimeter pad is contoured to drain to a sump in which a transducer has been installed to detect the presence of liquids and measure the depth of the liquid in the sump. A data collector takes these measurements every minute and stores the information for download and analysis. In addition to the moisture information collected from the lysimeter pads, a weather station collects rainfall, temperature, humidity, wind speed and direction, as well as solar radiation on the same measurement interval.

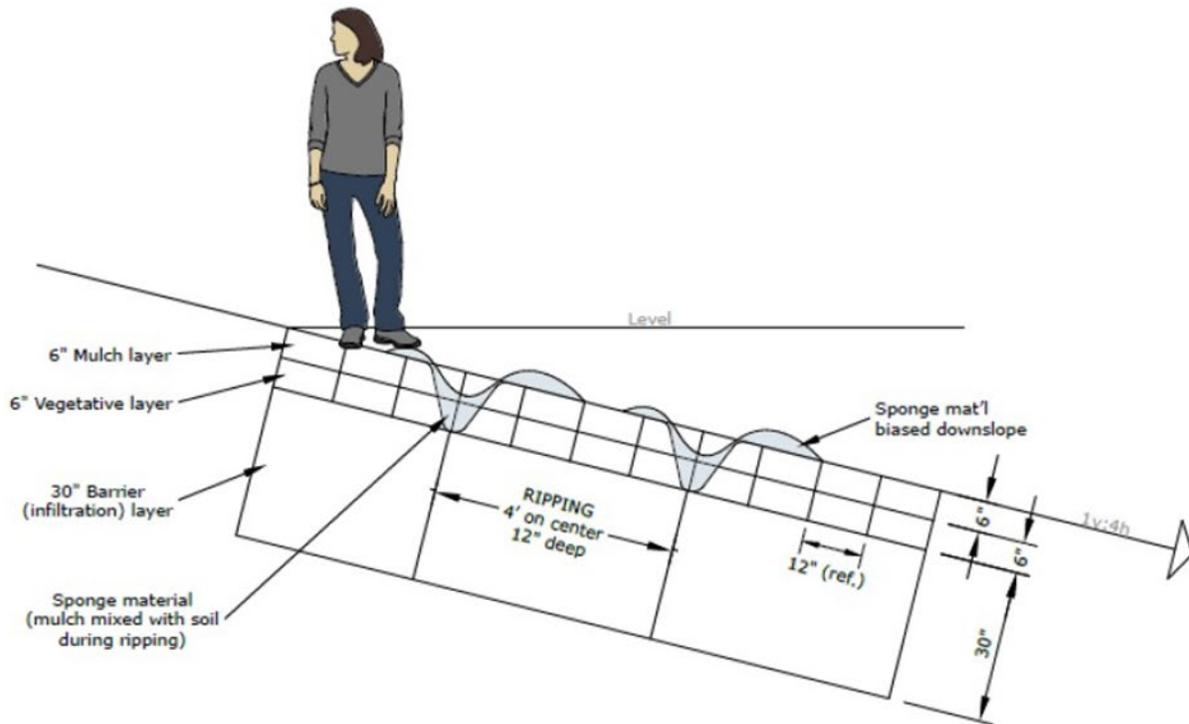
In an effort to improve the function of the cover system, Soilutions suggested the installation of what can best be described as an “Organic Sponge”. As depicted in the Figure above and the cross-sections adjacent, a bulldozer with two “ripping” tines was drug across the surface of the Lysimeter Pads folding and mixing wood chips and soil in a one-foot deep trench. This trench is designed as a break in the flow of liquids across the surface, allowing them to be absorbed into the cover. Hydraulically, this trench disrupts the surface flow reducing the velocity to zero and mitigating the potential for erosion.

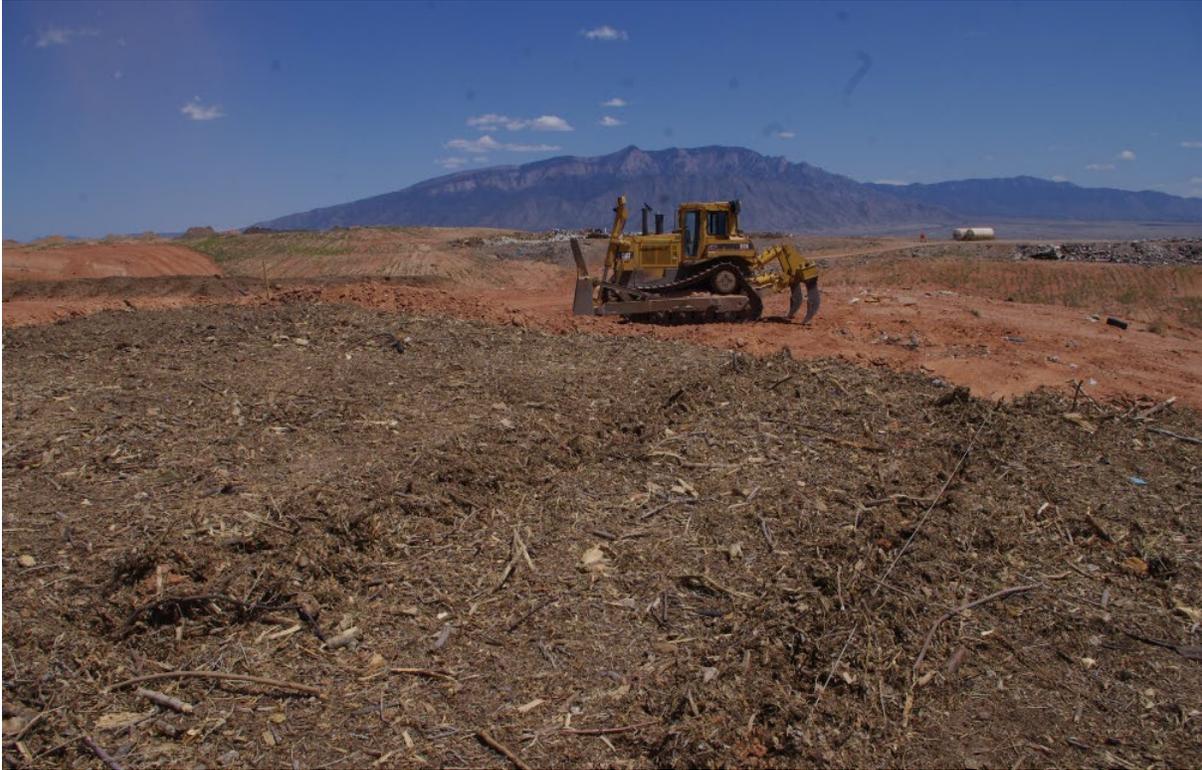
Placed at ten-foot contour intervals, the Organic Sponge will be ideally situated to mitigate erosion rills every forty feet slope intervals (on a 4H:1V grade) where typical rill propagation was observed on similar soil slopes at the landfill. This allows moisture that would have otherwise created significant erosion as it moved along the slope to be captured in the infiltration layer to promote vegetative growth on the cover system.

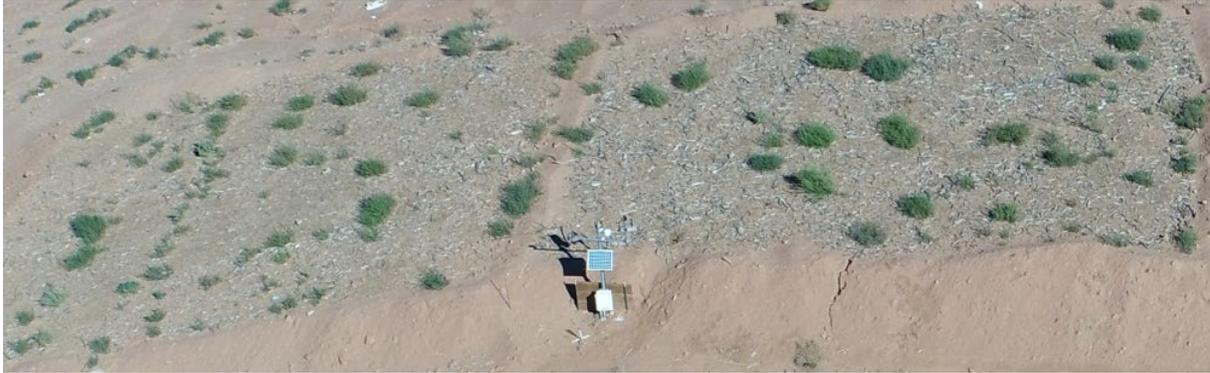
The Lysimeter Pads have been in operation since the spring of 2016 seeing the first measurable rainfall in June of 2016. Since that time there have been numerous measurable rainfall events but no evidence of percolation penetrating the Infiltration Layer as confirmed by the moisture sensors and the liquid level transducers in the sumps.

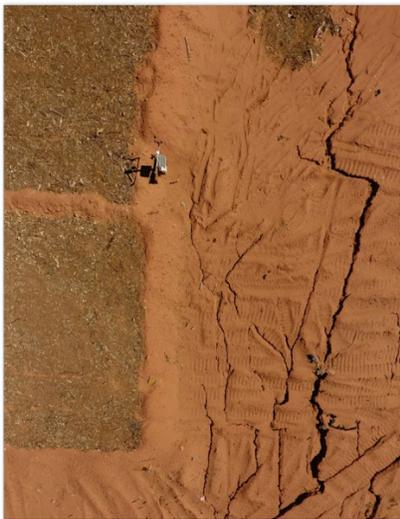
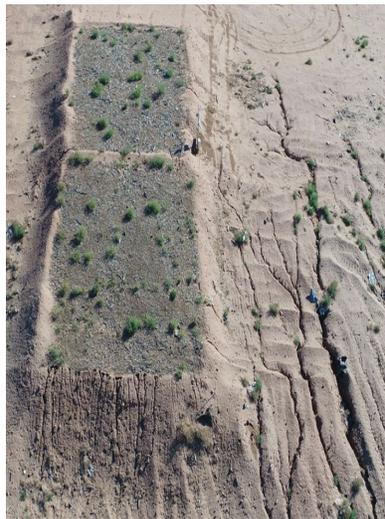
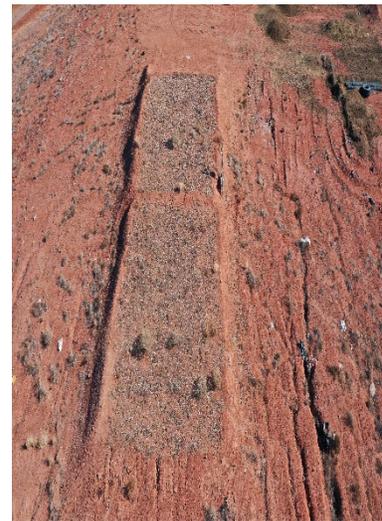
### ***Mitigation of Erosion***

The mitigation of erosion is the most significant finding observed during the intervening four-plus years that the lysimeters have been in place (Since Spring 2016). As observed in the photos (Left-September 2016 and Right September 2018) the soil cover surrounding has experiences significant erosion rills while the lysimeter pads themselves show no signs of erosion. This is a critical observation considering that erosion rills represent the single major failure of cover

systems in New Mexico. The armoring provided by the wood chip vegetation layer and the organic sponges installed to dissipate flow on the slopes have prevented the development of rills.

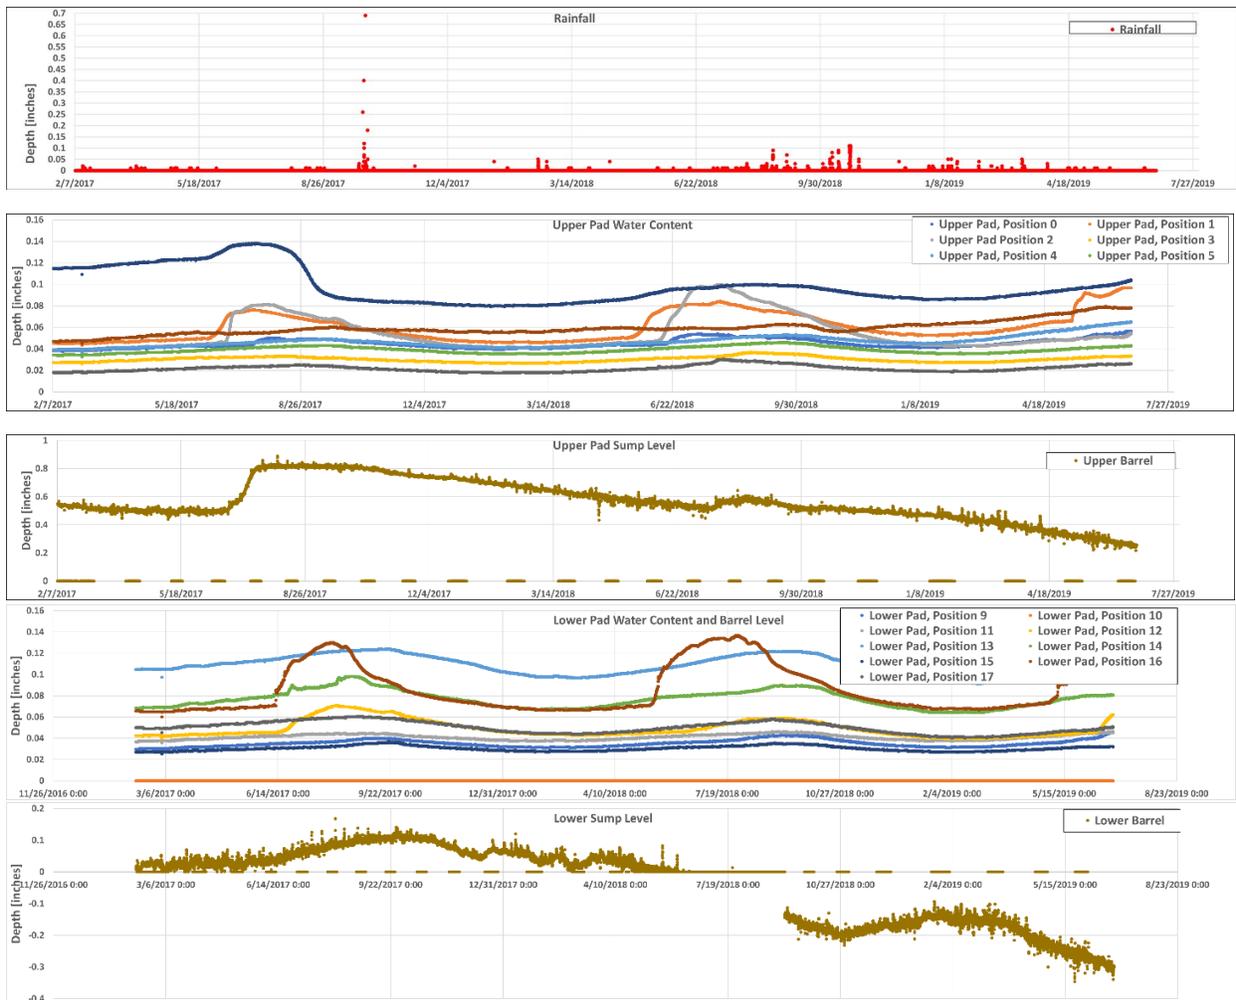
### **Mitigation of Infiltration**

Based on the lysimeter data collected, there has been no infiltration observed through the Organic Evapotranspiration Cover. This is evidenced by the presence of significant rainfall events (for New Mexico) with no detection of moisture at the 32 moisture sensors distributed across the two lysimeter pads.

In addition, there was no discernable accumulation of liquid in the two lysimeter sumps confirming the absence of infiltration demonstrated by the moisture sensors.

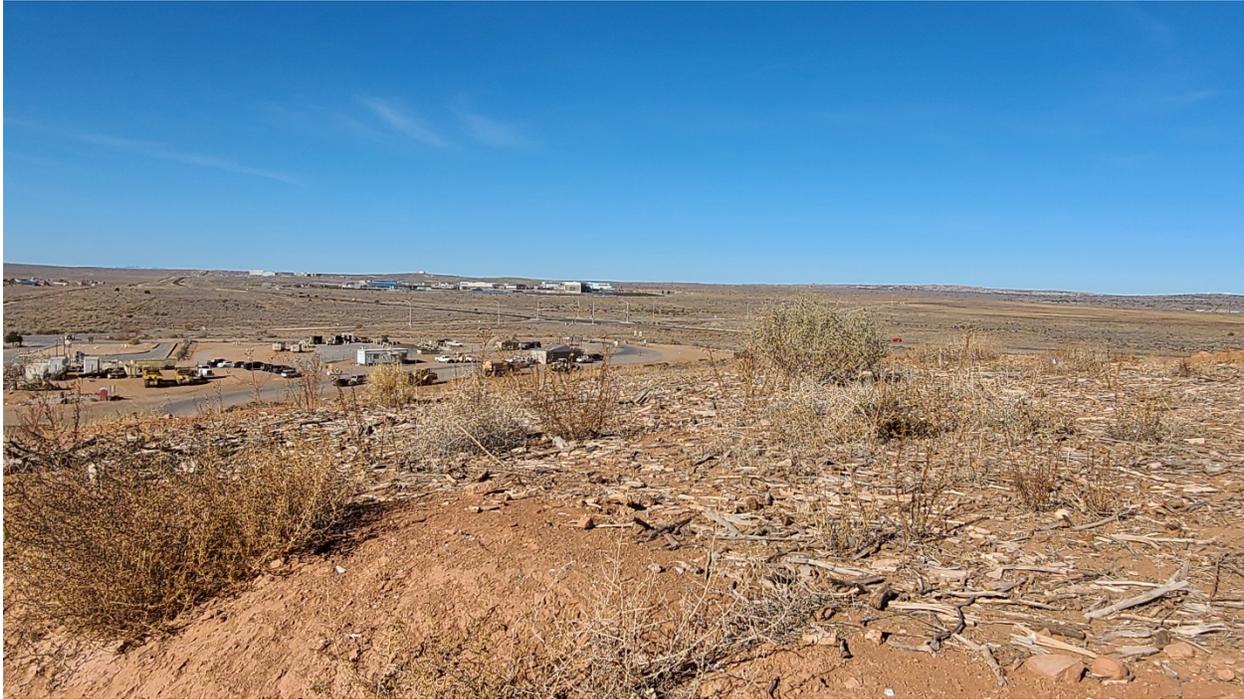
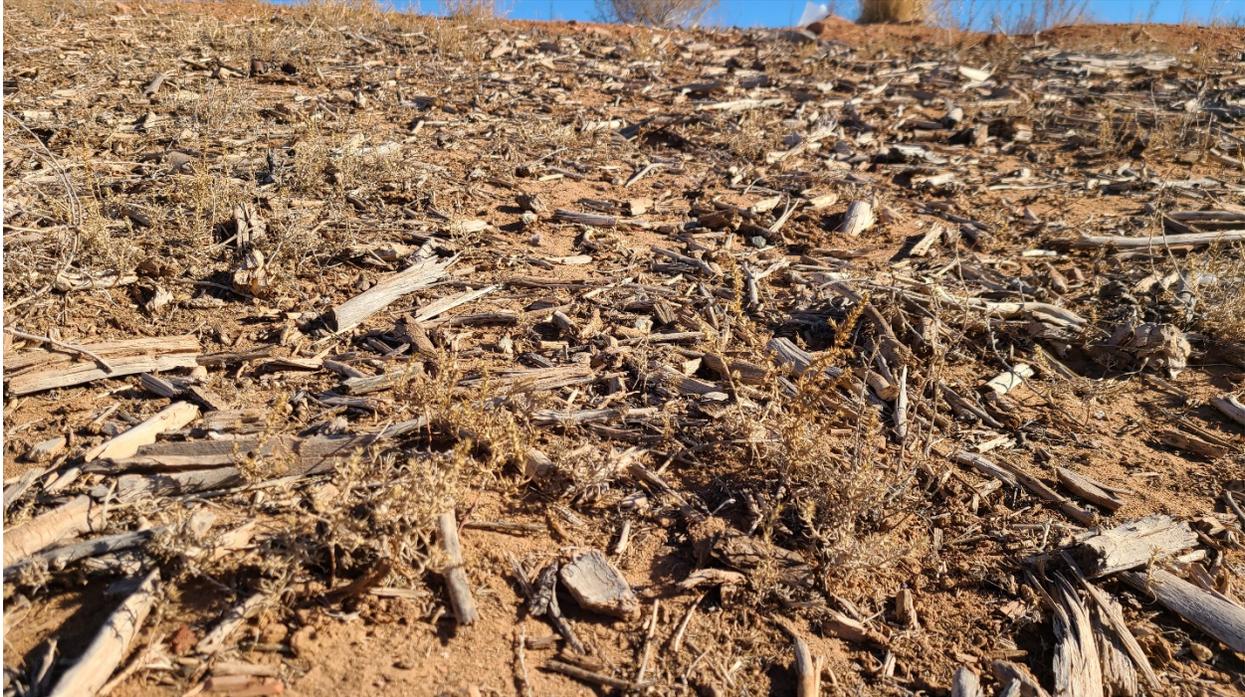
### *Vegetative Base*

Current observation of the lysimeter surface confirms that the anticipated development of a soil zone resulting from the degradation of the organic material placed as a component of the cover system is occurring. The presence of “volunteer” vegetation is evidence that the vegetation layer of the lysimeter pads is capable of supporting plant growth. Seeding this layer, which is typically a requirement of final cover closure plans, would encourage the development of this vegetative cover. The ultimate goal of developing a soil zone capable of supporting vegetation appears to be possible in as little as two years fulfilling the ultimate goal of this evaluation.
